## Service Bulletin 4812 718 40305

**TITLE:** Condensation

**SUBJECT:** Condensation on kitchen furniture, kitchen worktop, control panel in combination with DW POINT appliances

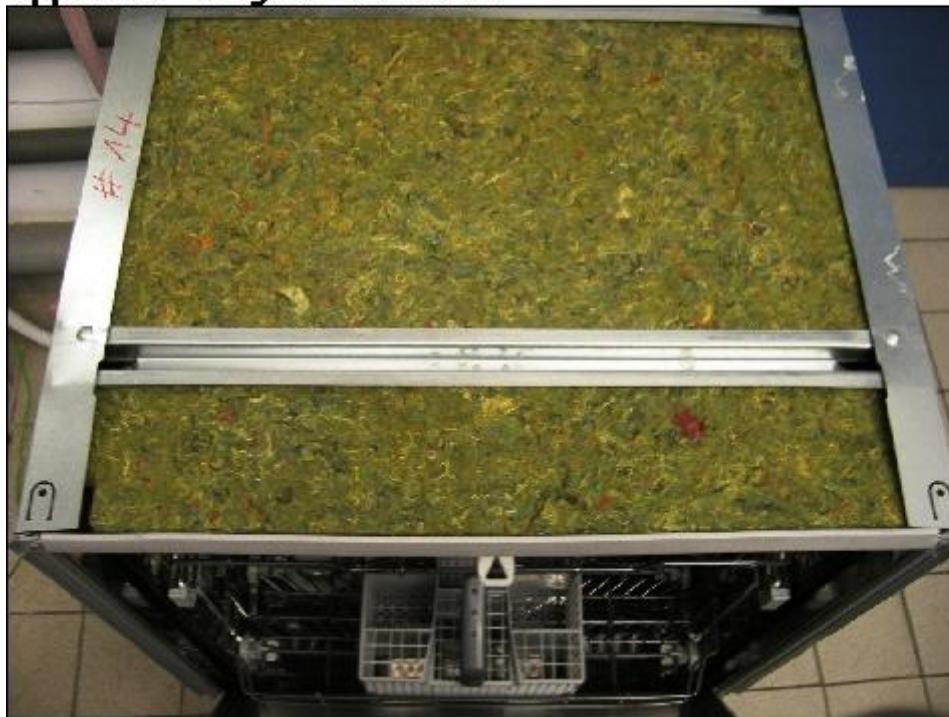
**Appliance – original condition**

For cases where the steam escapes from the door area, there is the following procedure possible:

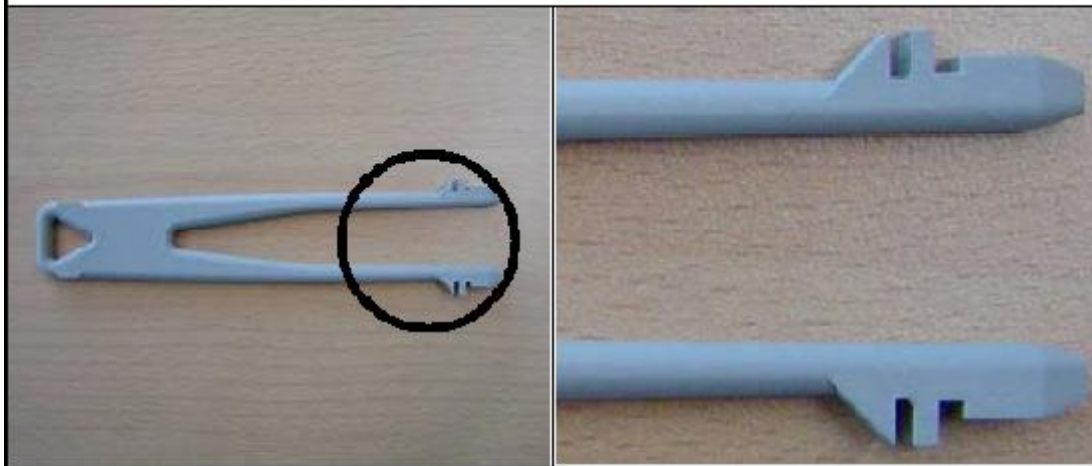
Due to tolerances in production, there could be the case, that the door doesn't close properly, which leads to out coming steam, loud noise or clear hearable hydraulic work and condensation under the worktop in the kitchen.

Additional slot on the latch

**Spare part number 4812 401 18887**

After the intervention, check the door closure while running an intensive program reg. out coming steam, leakages or noise of incoming water (hearable, when the door doesn't close properly)

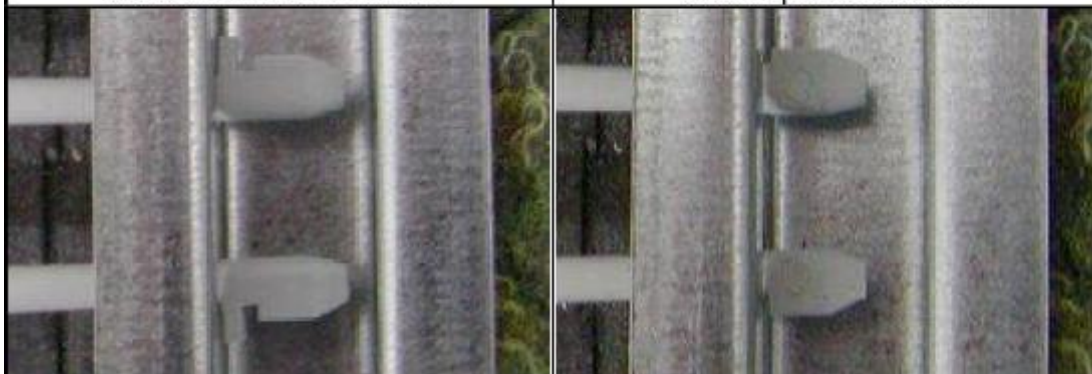
Close-up of the 2 slots

Position to tighten the closure of the door

Normal position

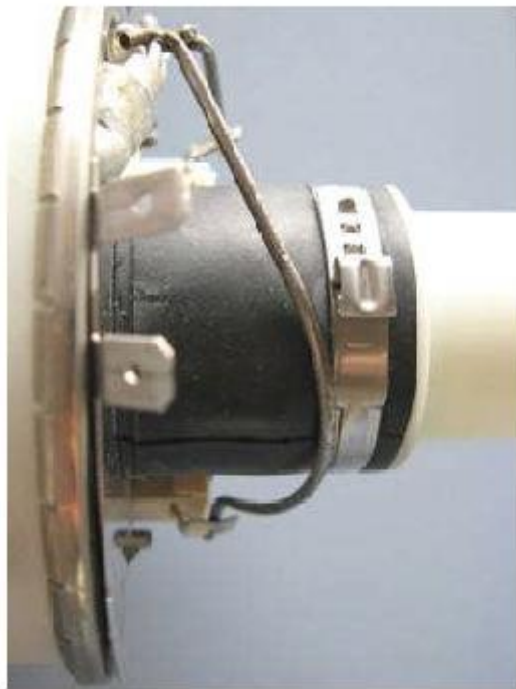
**Wrong**

Under certain circumstances the distance between the wiring of the heater coil and the rubber part is too less. This lead to a creeping current circuit between the heater wiring and the rubber tube.

- Check during every intervention if the position of the heater wiring is correct.
- Realign the position that the wiring is parallel to the heater metal sheel.

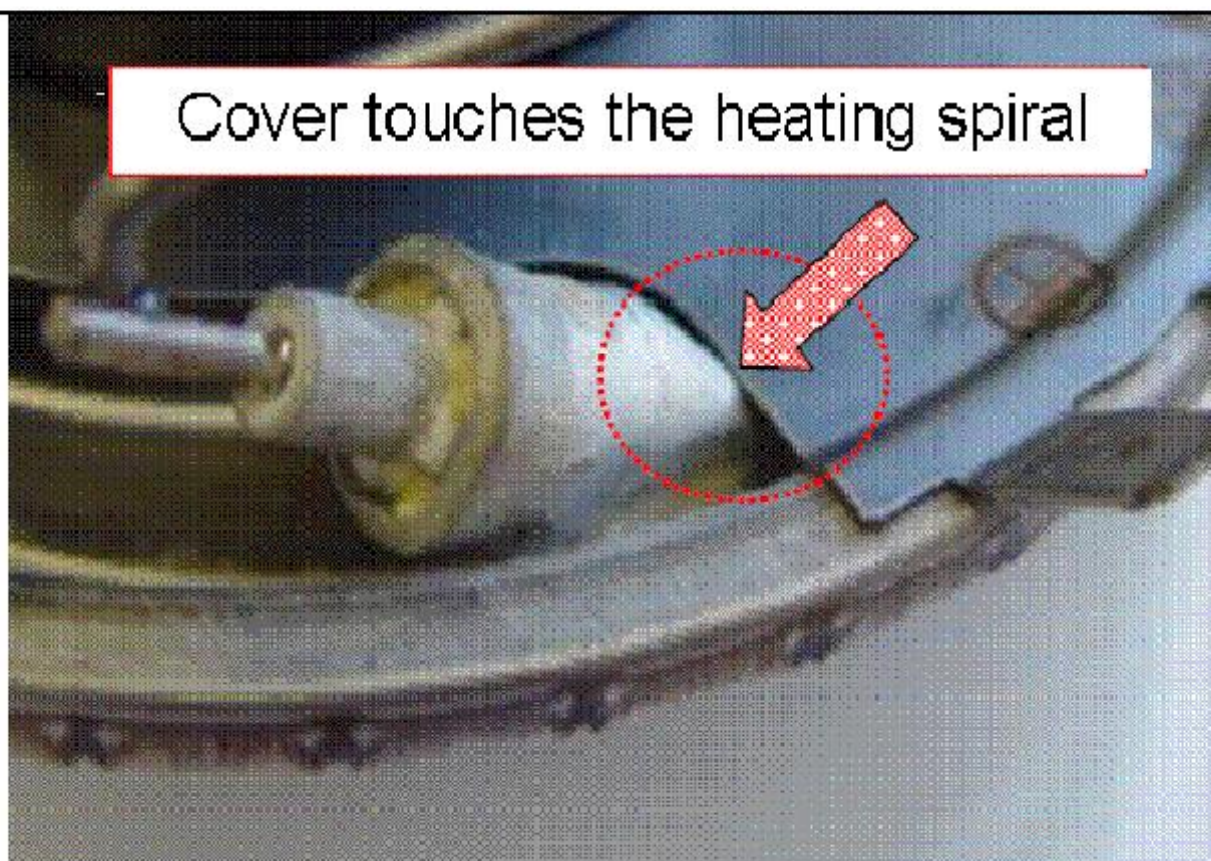
**Wrong alignment**

Due to the production process at the supplier of the integrated heating module, there is the possibility, that the cover touches the heating spiral. This could lead to a noise during the heating phase in a wash program at a defined speed.

To solve the issue, bend the cover in this area very carefully a little bit (see second picture) to ensure, that the heating spiral isn't touched by the cover.

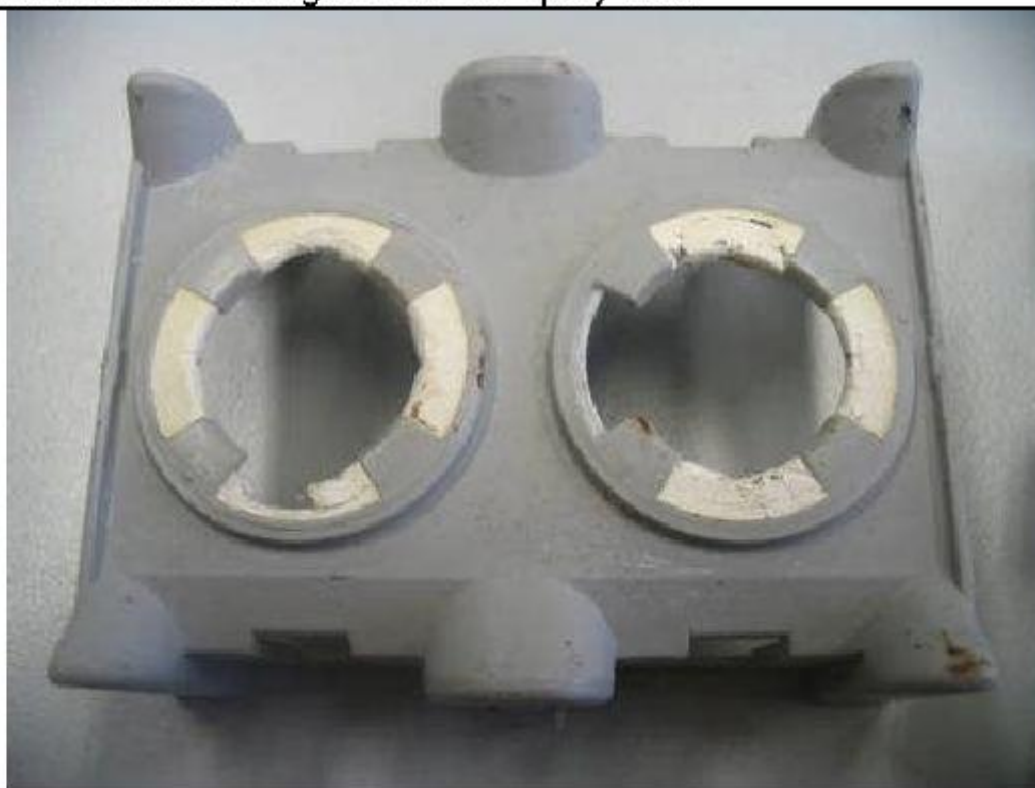
Customer complain about declining of washing performance

The elastic plastic part of the nozzle unit wear out and lead to internal leakage.  
A part of the water won't be guided to the spray arm.

Exchange the nozzle plate

- Take the main tube free on the metal clips.
- Then dismantle the nozzle plate from the main tube with slight pressure from the plastic hooks.
