## Service Bulletin 4812 718 40305

**TITLE:** Condensation

**SUBJECT:** Condensation on kitchen furniture, kitchen worktop, control panel in combination with DW POINT appliances

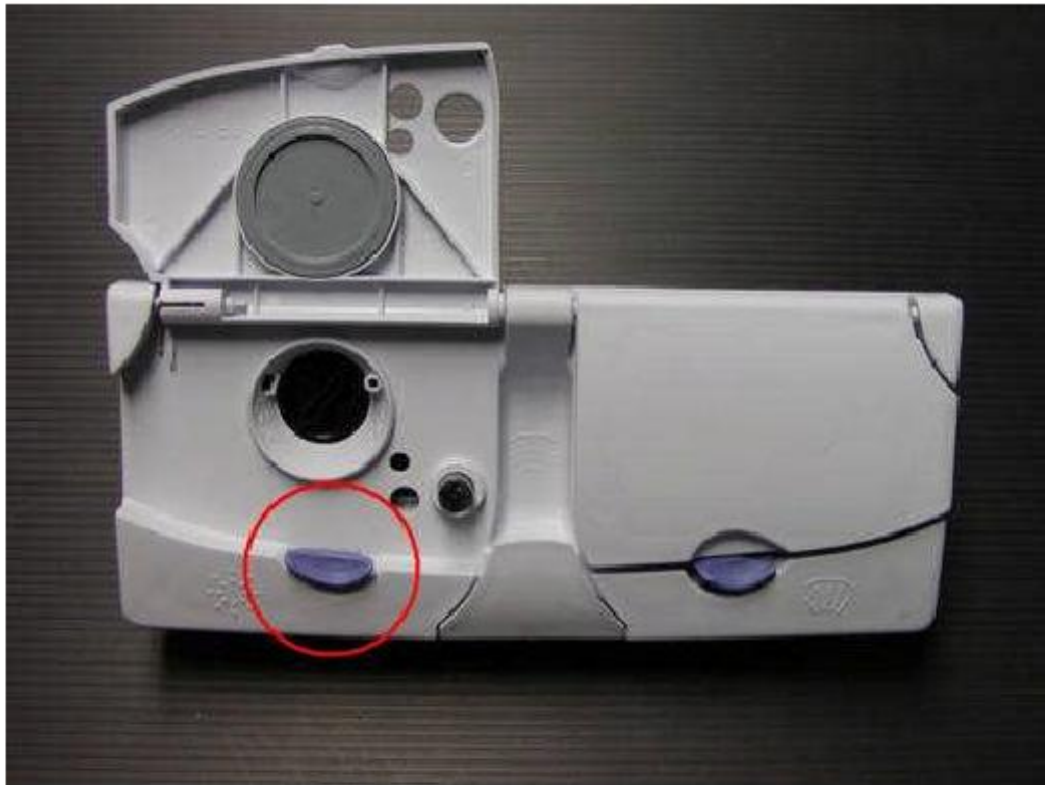
The clip is only available in the colour-version "opaco-blue" as shown on the picture.

The clip is removable by using a small screwdriver. It is not necessary to dismantle the door for the access to the clip.

**Spare part number:** **4812 440 11209****SIRIAS code:** **M 6800 10**

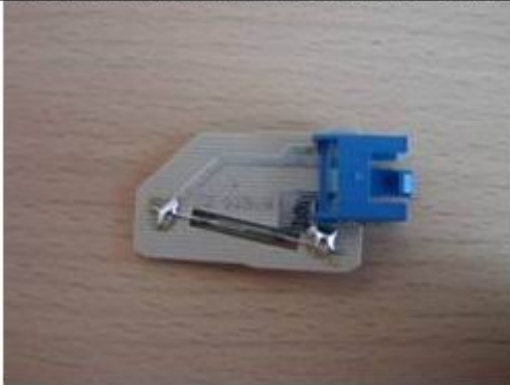
The version Aweco with blue socket.

As Service solution you can order both Flow Meters as Service Kit in one packaging:

Service Part 12NC for both reedcontact PCB's : 4812 310 19147

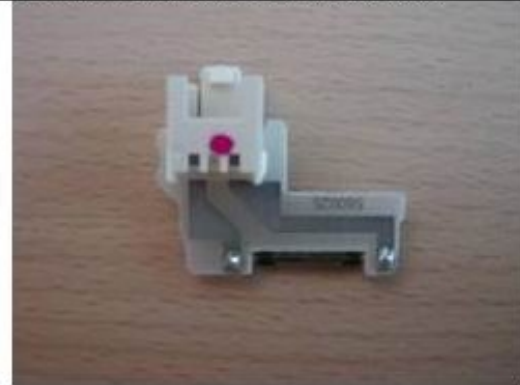
The version Bitron with white socket.

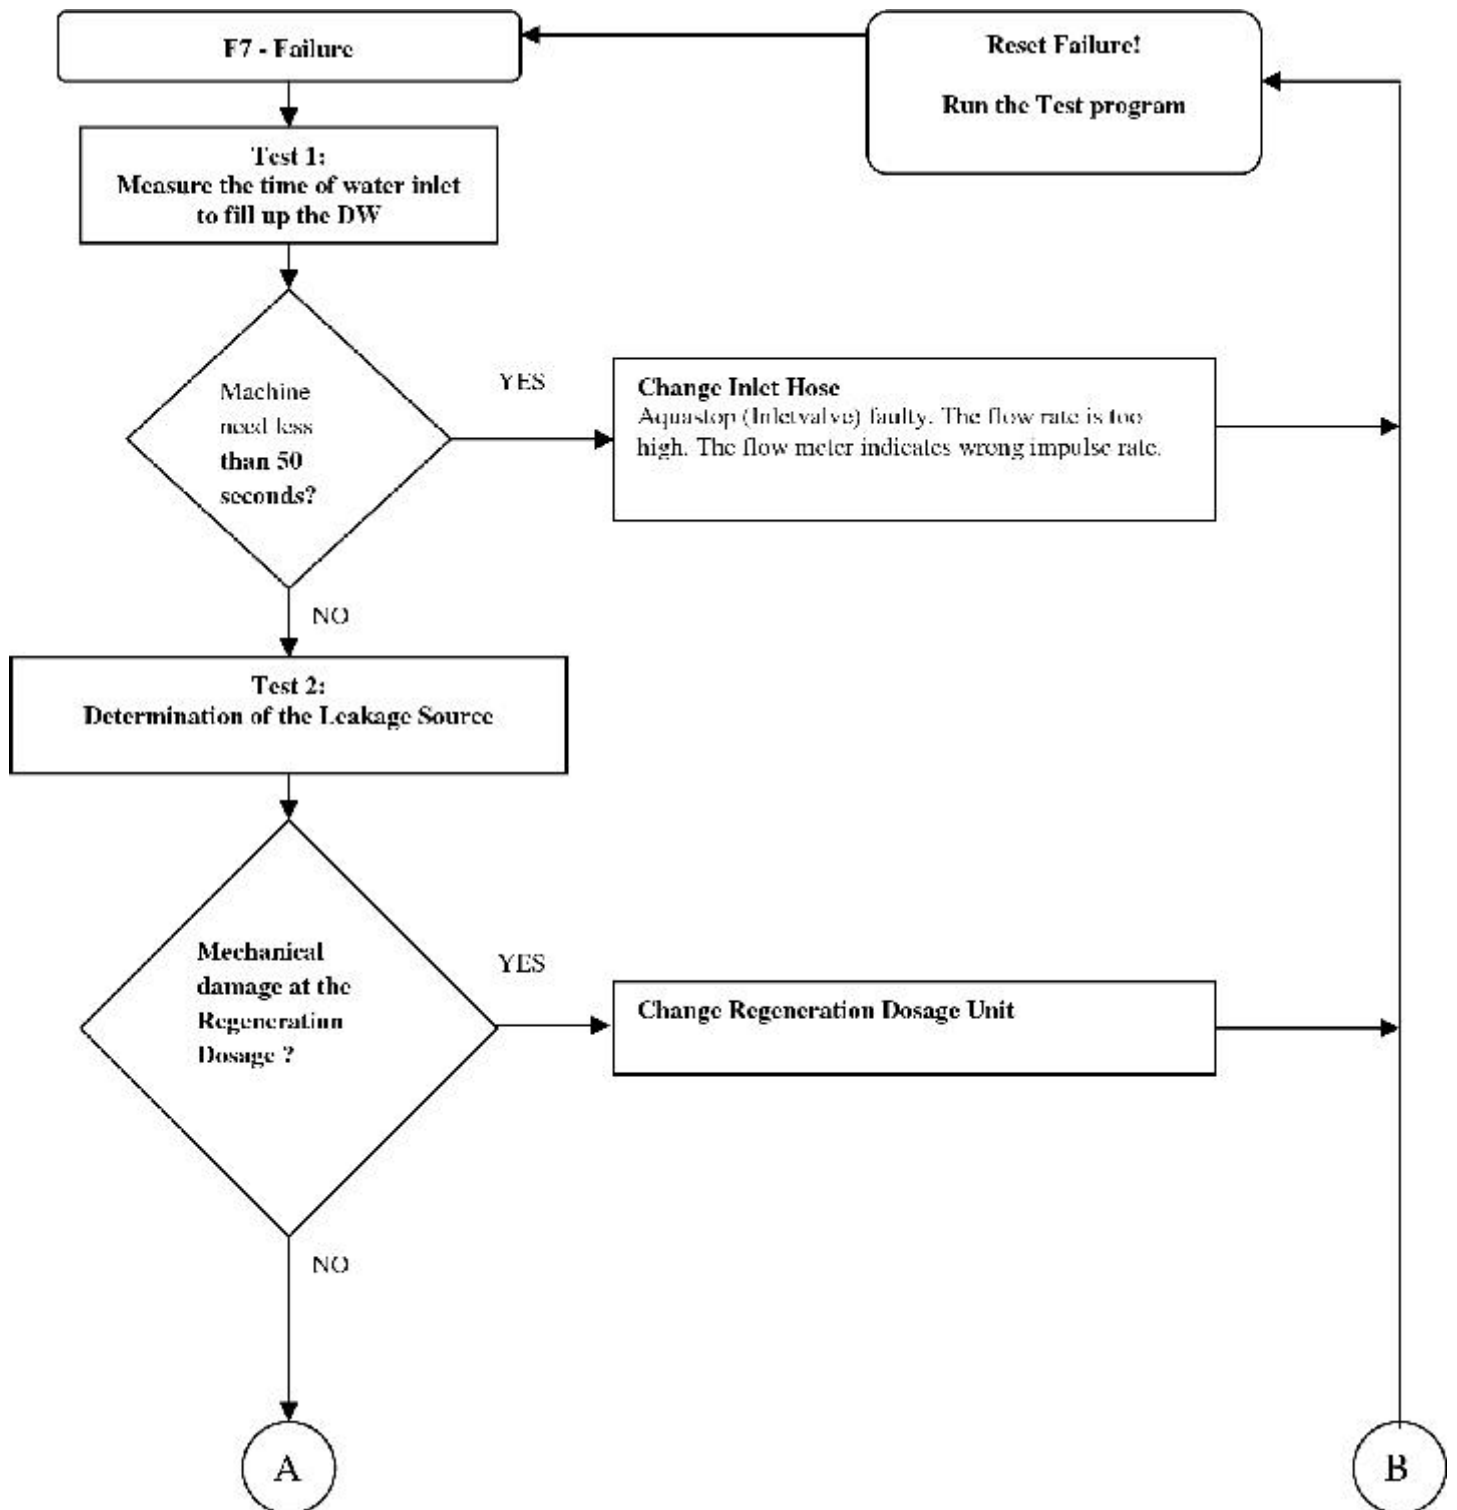
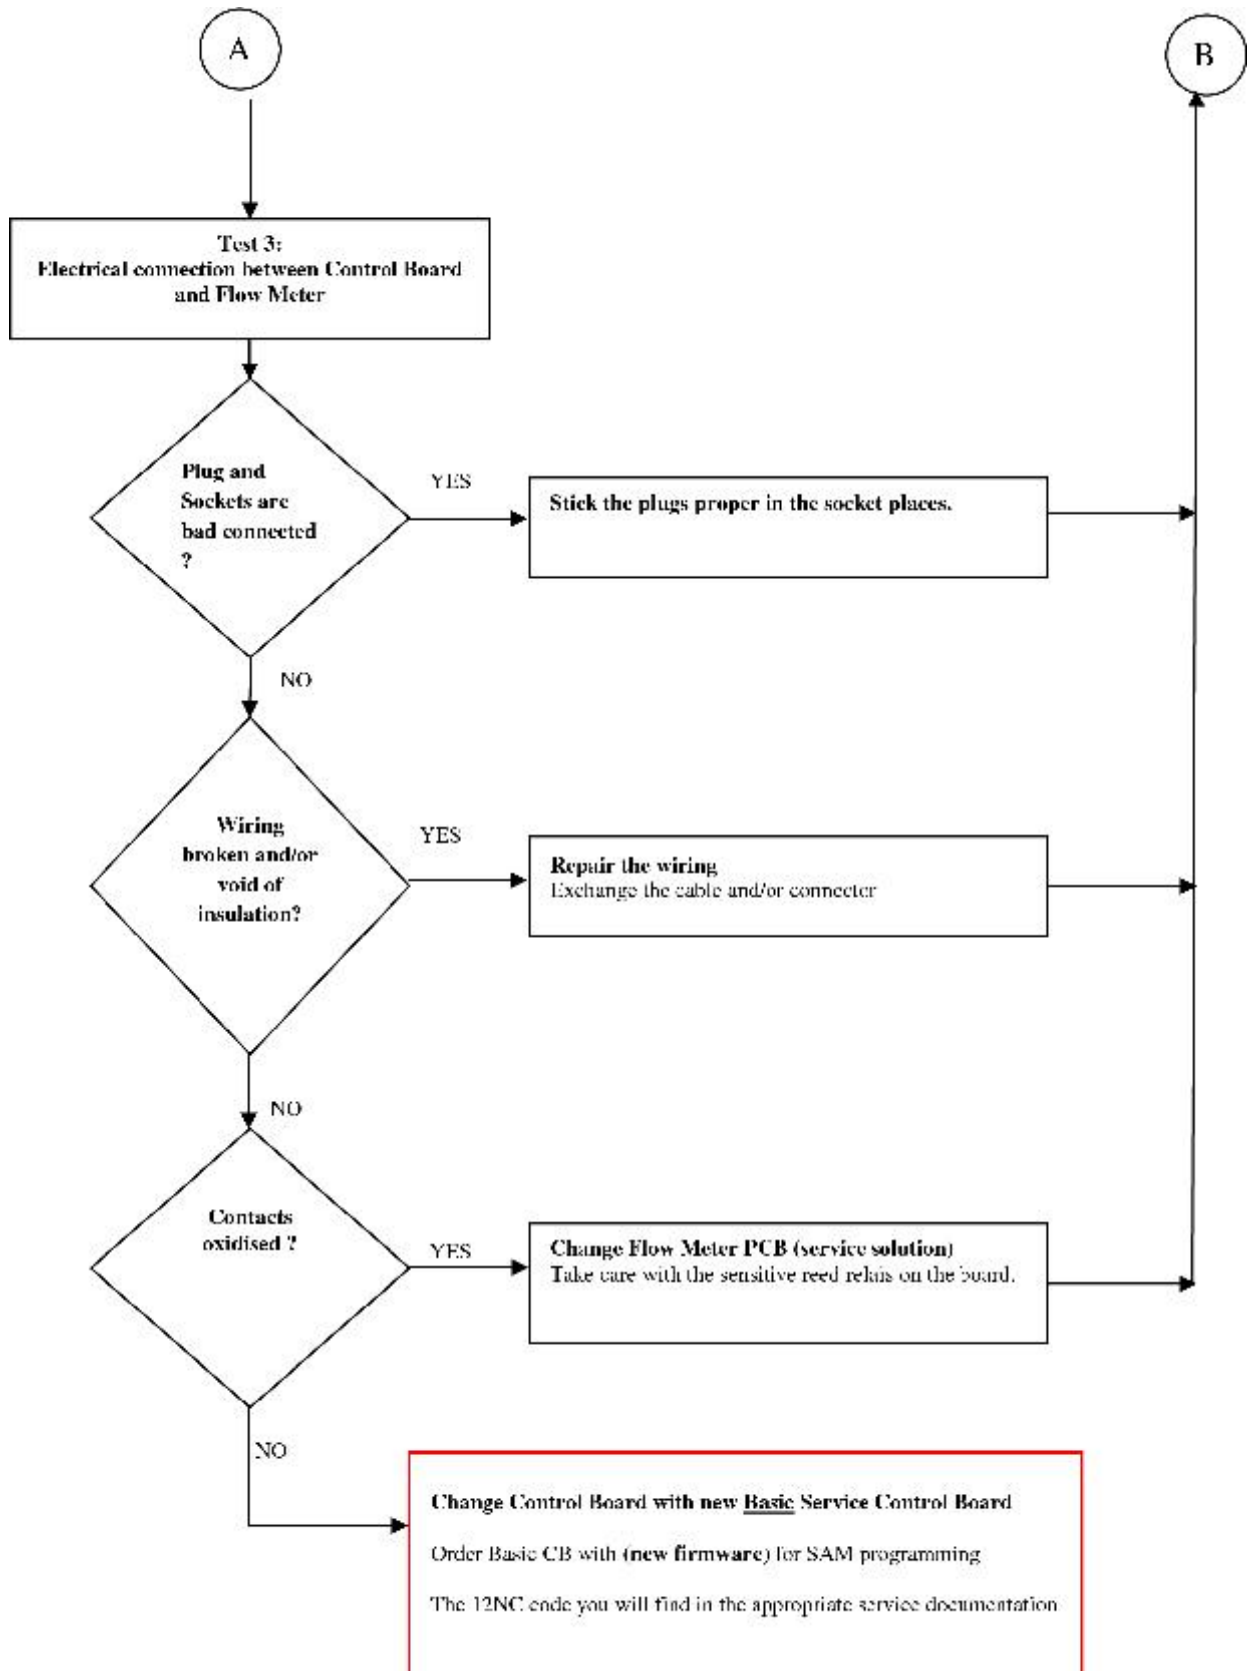
**Service Bulletin 4812 718 40201****AUTHOR:** Mladen Carzavec**Last Update:** 04/19/10**VERSION:** 1.1**TITLE:** F7 error code. Flow Meter – Failure.**SUBJECT:** When the F7 error code appears - the root cause is often not the Flow Meter itself.

Leakage on the regeneration dosage , Aqua stop valve , Wiring , Flow Meter PCB,or the control board has to checked.

Please go through the attached failure flow diagram to determine the root cause.

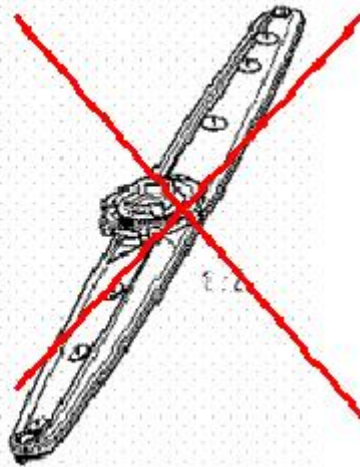
NO MORE AVAILABLE

Please order instead of the Single Spray Arm
